Shaft crack detected at an ammonia plant

Cracked shaft on C602 Syn Gas Compressor

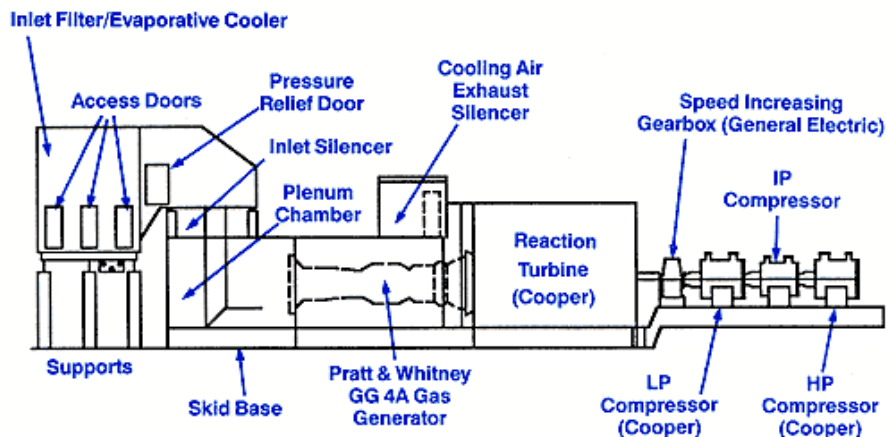
The Synthesis Gas Compressor, C602, is the most critical machine in the petrochemical complex. Its configuration (Figure 1) is unusual in that a steam turbine driver is not employed. Instead, the compressor train is driven by a Pratt and Whitney GG4A-2 gas generator exhausting into a Cooper Bessemer, 18,000 HP reaction turbine (RT). The RT drives three Cooper Bessemer centrifugal "barrel type" compressors

Figure 1
Gas turbine compressor unit outline.
